ASSESSMENT OF THE CHURCH OF THE ADVENT CEMETERY, SPARTANBURG, SOUTH CAROLINA

Chicora Research Contribution 571

August 2016

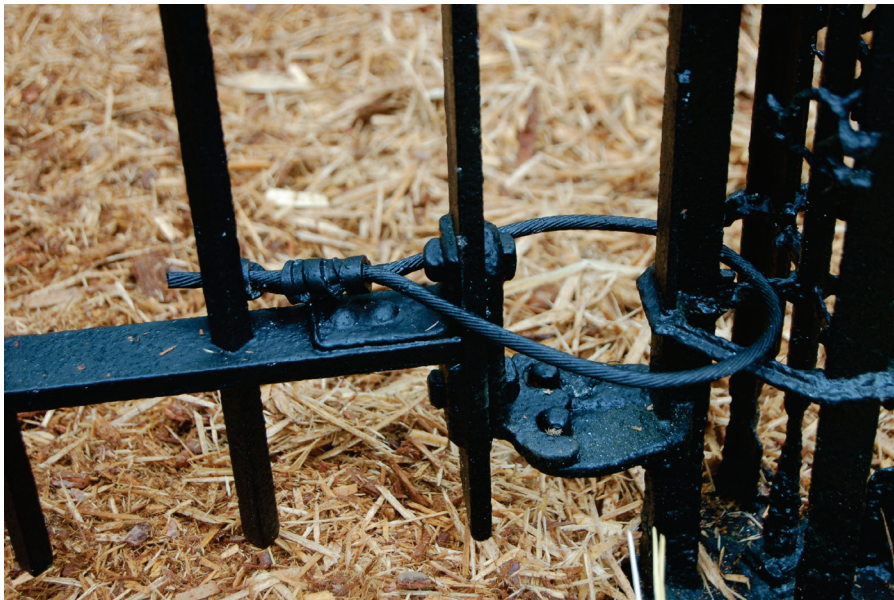
Figure 25. Example of a gate protected with stainless steel cabling that has been painted to blend with the fence.

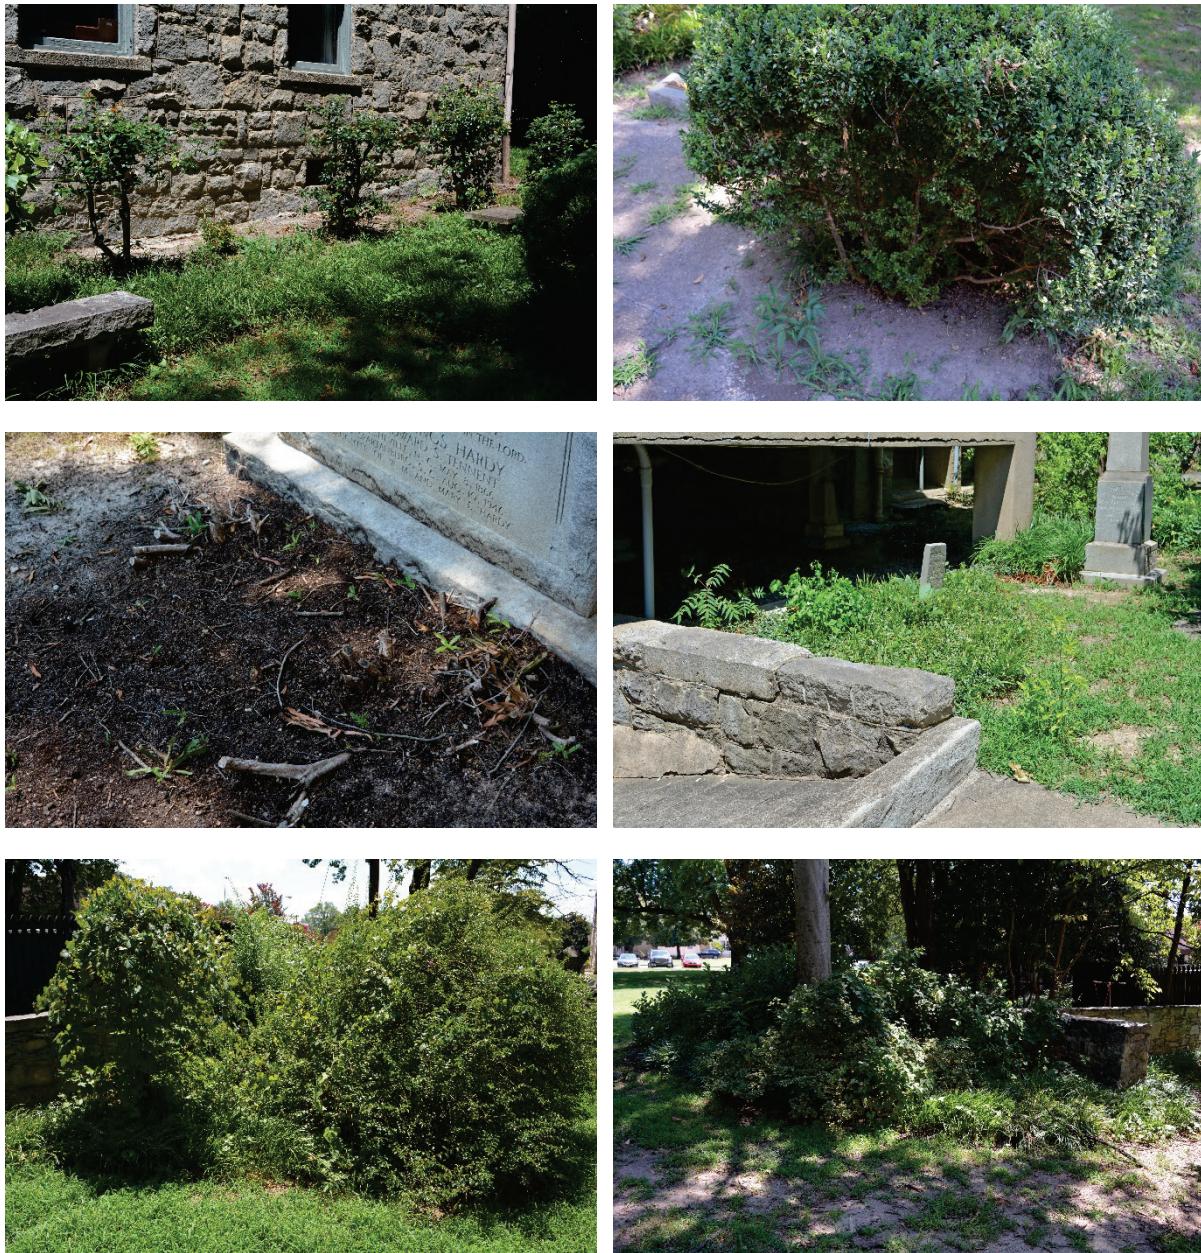
Figure 35. Shrubby problems. Upper row photos show improperly pruned and damaged shrubs. Middle row left photo shows a shrub that has been chopped down to the ground. Middle row right shows weeds overtaking liriope bed. Lower row photos show two clumps of shrubs that are entirely overtaken by weeds and vines to the point that it has become impossible to distinguish the shrubs from the invasive vegetation.

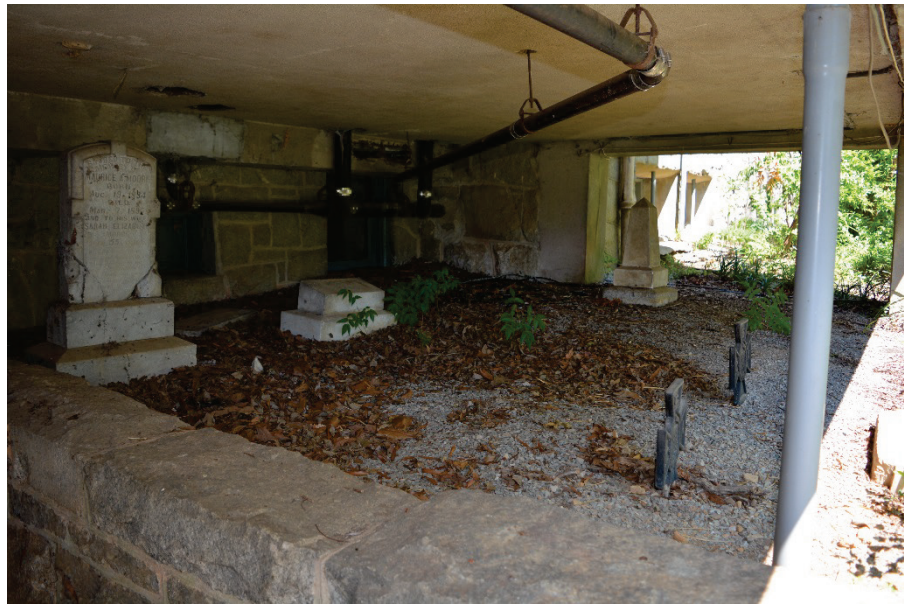
Figure 41. Orphan stones. Are these stones associated with graves or are they orphan or replaced stones?

Stones should never be allowed to be removed from their original location without full documentation – where was the stone found, why is it being removed, where is it being stored, what should be done to reset the stone, what action is being taken to resolve the issue. Staff must understand that once a stone is separated from the grave, the potential that the grave will become lost

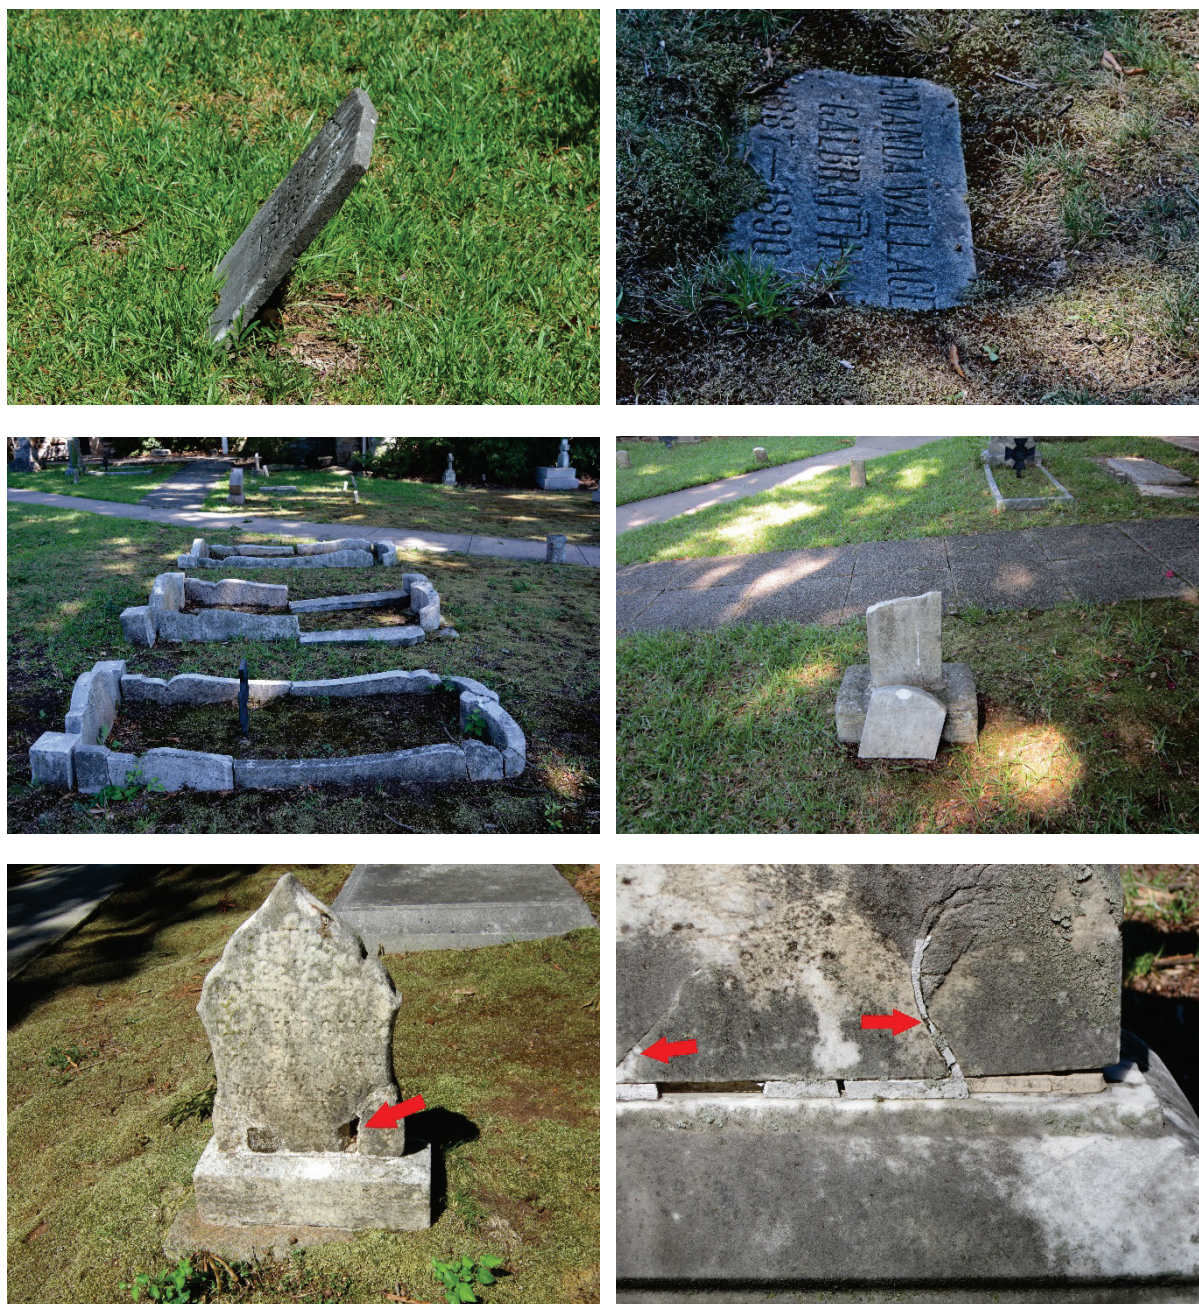
Figure 46. Examples of stones requiring conservation treatment. Upper row left shows a badly tilted stone. Upper right shows a sinking lawn marker. Middle left shows three cradle graves that are broken, displaced, and sinking. Middle right shows a broken tab in socket stone. The lower photos show two die on base markers attached using ferrous pins that have corroded and caused damage to the monuments.
